HANCOCK COUNTY – BAR HARBOR AIRPORT
Environmental Assessment
Avigation Easement and Obstruction Removal Project

**Federal Aviation Administration
Maine Department of Transportation
March 2022
Environmental Assessment**

**Avigation Easement &
Obstruction Removal Project
Hancock County – Bar Harbor Airport
Trenton, Maine**

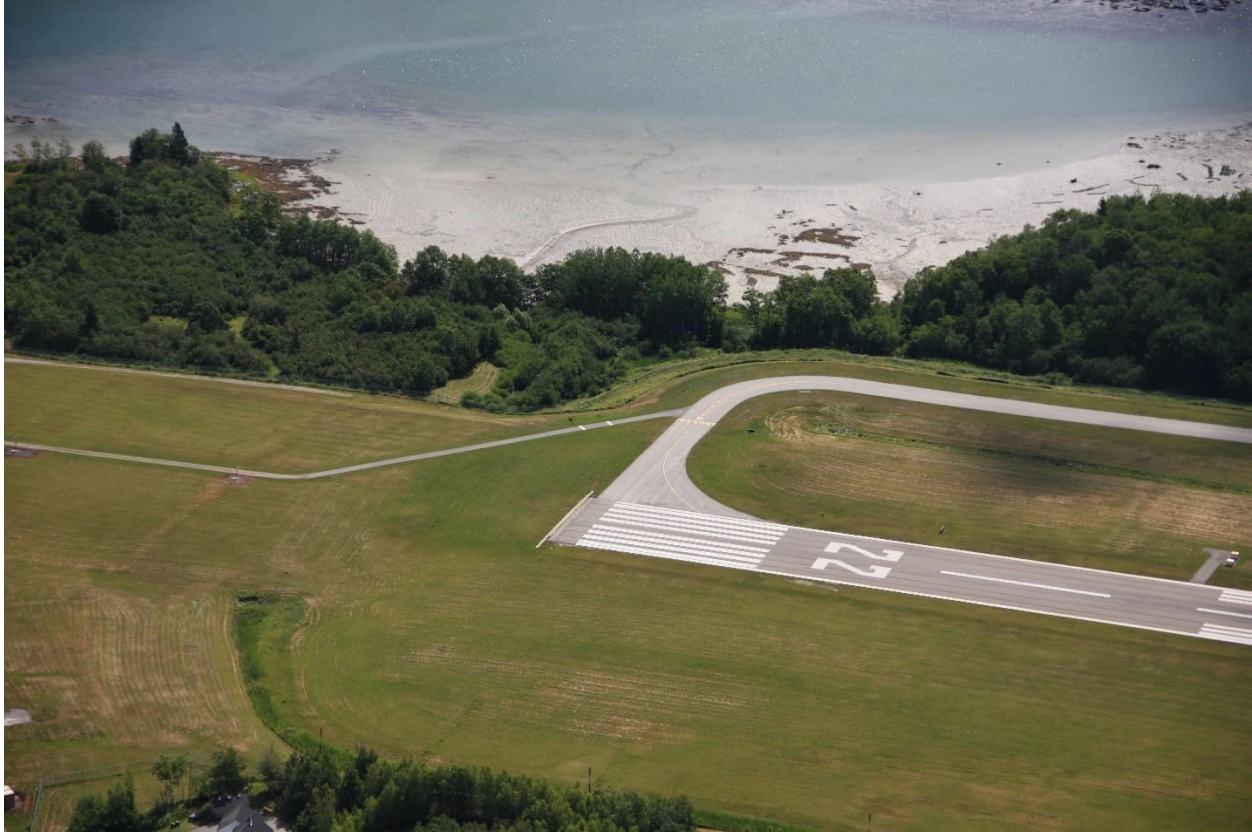
Approach end of Runway 22

The Airport has two paved runways. Runway 4/22 is 5,200' long by 100' wide with a Runway Design Code of C-II while Runway 17/35 is 3,364' long by 75' wide with a Runway Design Code of B-II. Runway 4/22 is the primary runway, extending in a southwest-northeast direction. Runway 17/35 is the crosswind runway which extends in a southeast-northwest direction. Runway 4/22 provides pilots with an Area Navigation approach RNAV (GPS). Additionally, Runway 22 offers precision instrument approach capabilities because it is equipped with an Instrument Landing System/Distance Measuring Equipment (ILS/DME). As noted in the Airport Master Plan, Runway 17 has a displaced threshold of 684' due to manmade and vegetative obstructions to the northwest. Runway 35 also has a displaced threshold of 111' due to vegetation on the edge of the shoreline off the end of the runway. The crosswind runway is a visual approach only. The threshold of Runway 17 intersects with Runway 22 approximately 1,800' to the southeast. No vegetation clearing needs to take place within the runway areas.
